# HDSS Survey of Parkerson Mill Creek *Project Report*

**Michael Freeman**  
**Dept. of Risk Management and Safety**  
**971 Camp Auburn Rd.**  
**Auburn University, AL 36849**

November 13, 2024

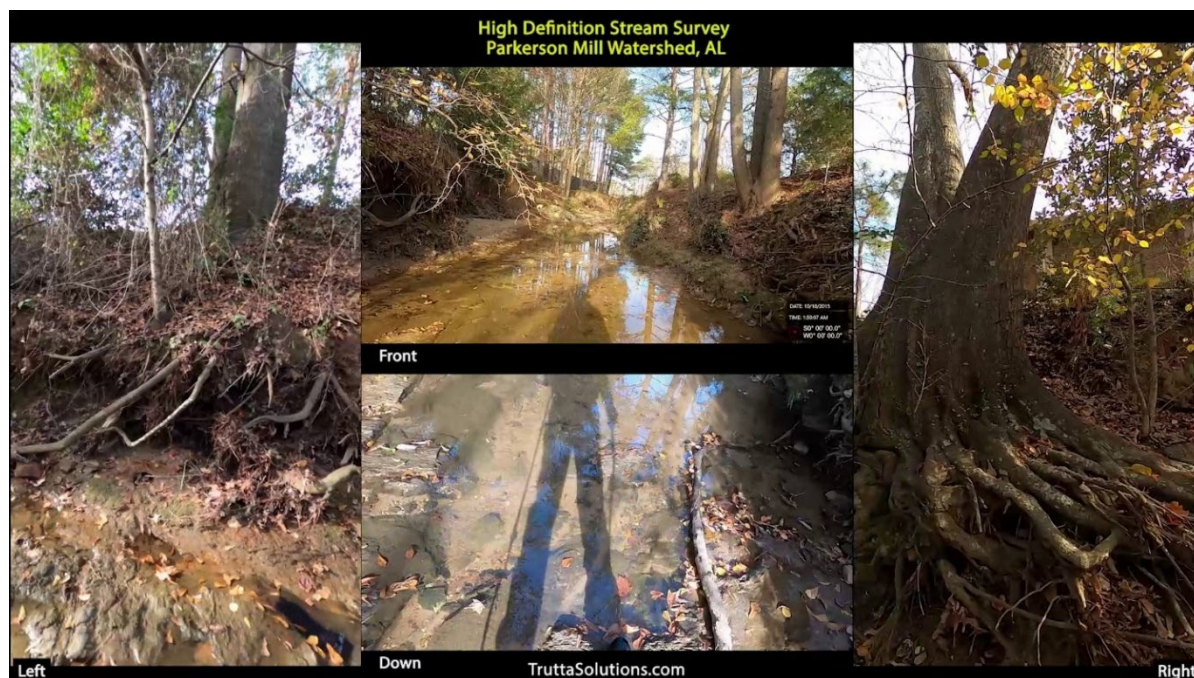
Figure 43: Generalized location between the McWhorter Center and Jane B. Moore Field, where the Combined Functional Score of the stream corridor was consistently Impaired for an extended distance.

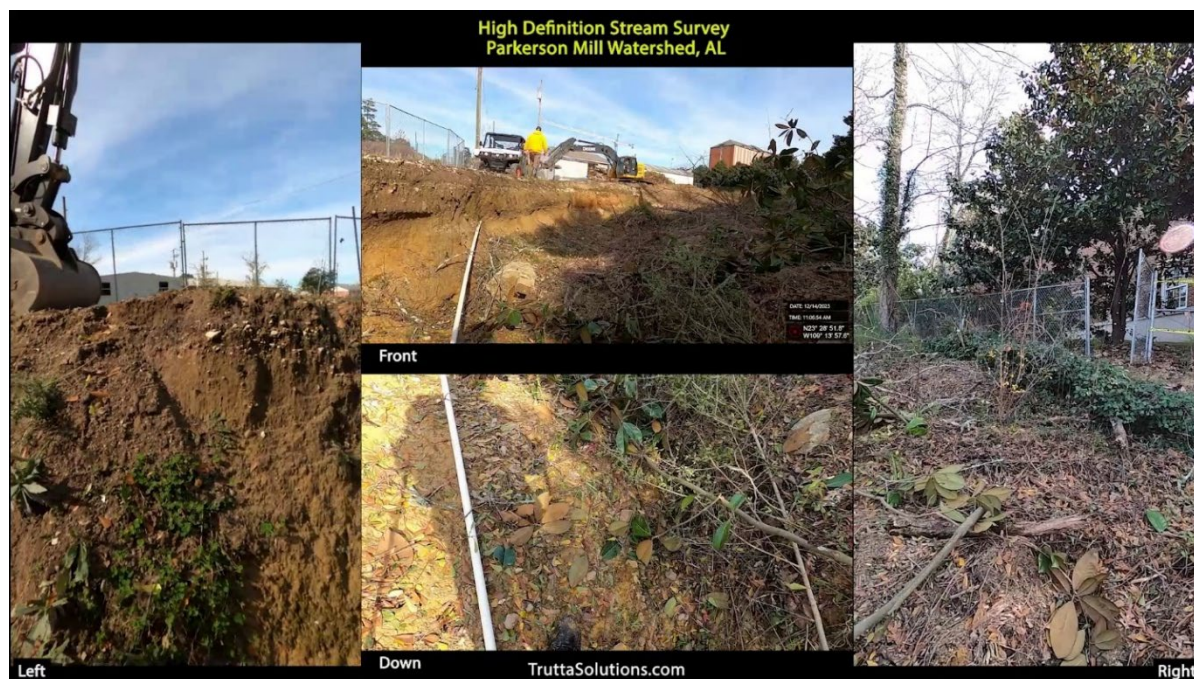
Figure 44: StreamView image of in- and near- channel restoration along AU Forestry segment of the survey.

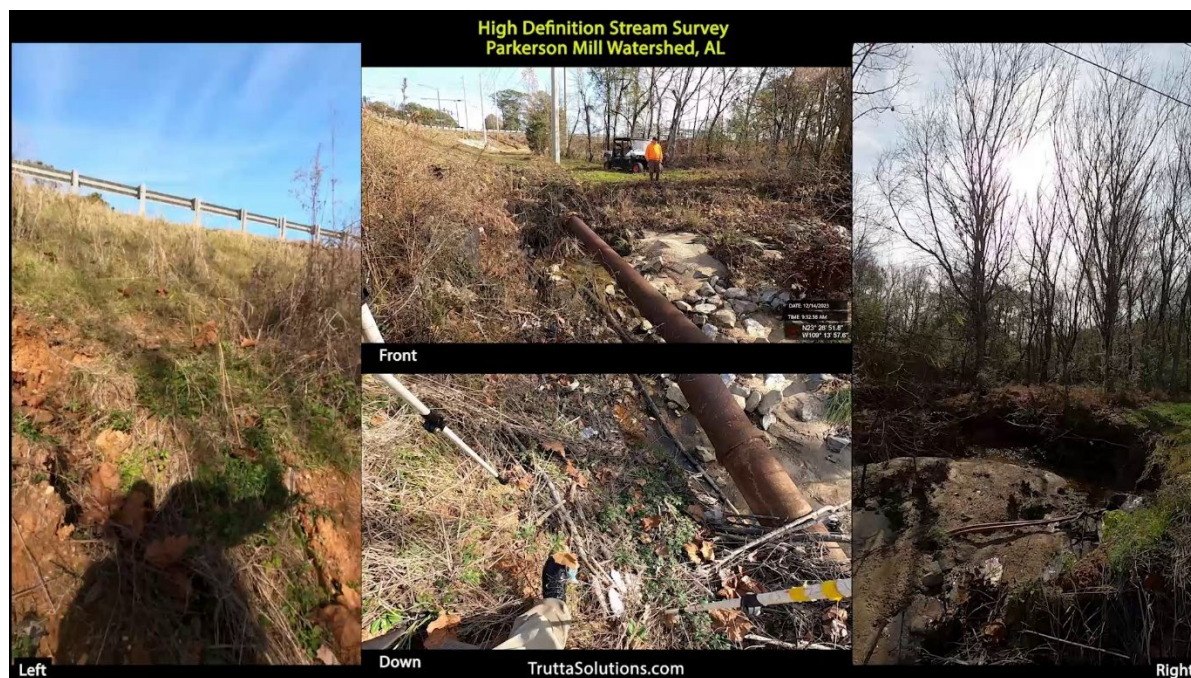
Figure 46: StreamView image of one of the worst reaches based on the Overall Condition score influenced by infrastructure (e.g., culverts and exposed pipes), along AU Beef Unit segment of the survey.

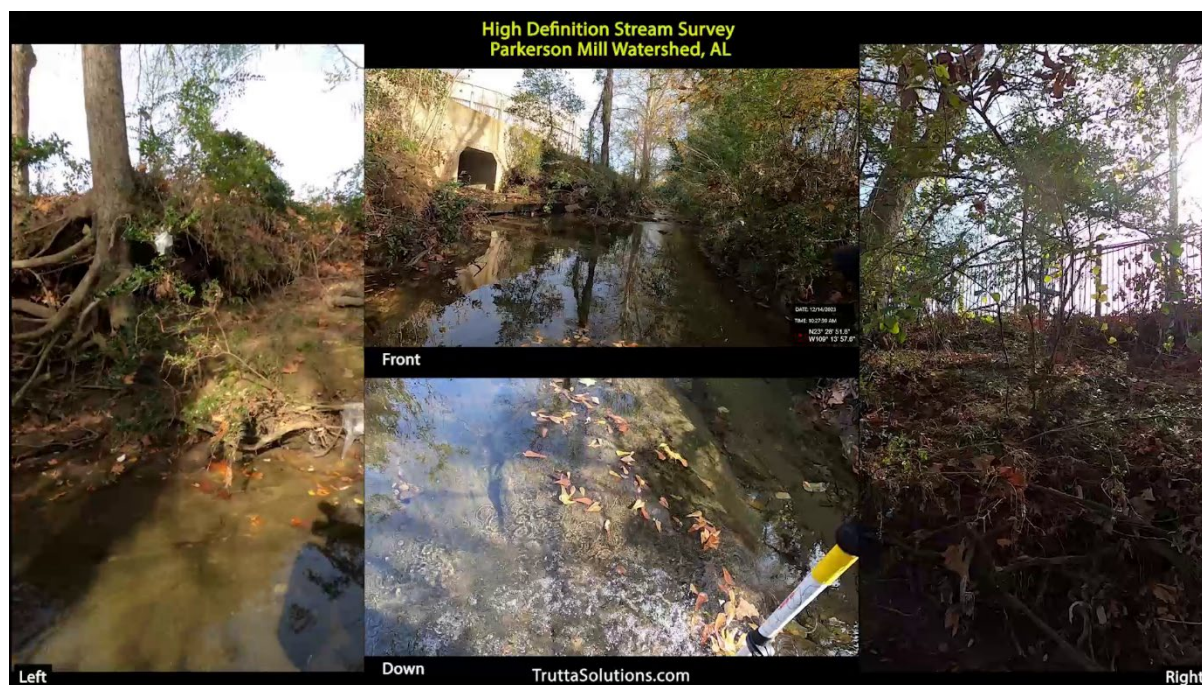
Figure 47: StreamView image of one of the worst reaches based on the Overall Condition score influenced by infrastructure (e.g., culvert), along the Coliseum segment of the survey.

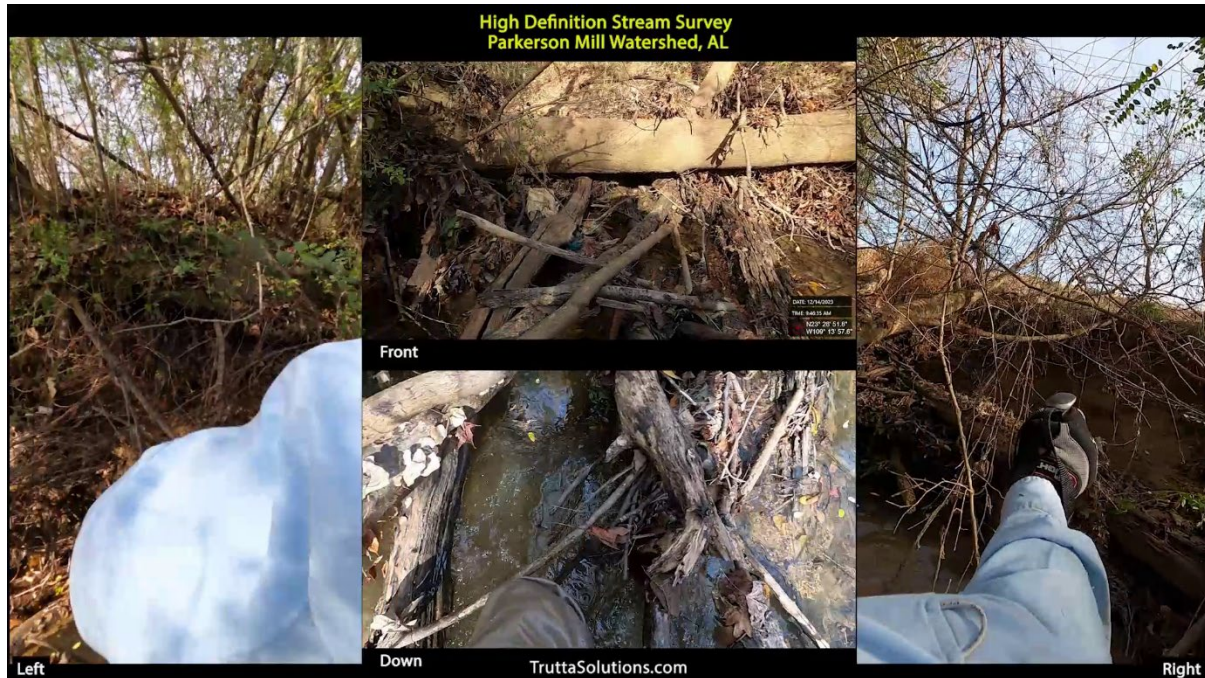
Figure 48: StreamView image of one of the worst reaches based on the Overall Condition score influenced by natural feature (e.g., log/debris jam), along The Hub segment of the survey.

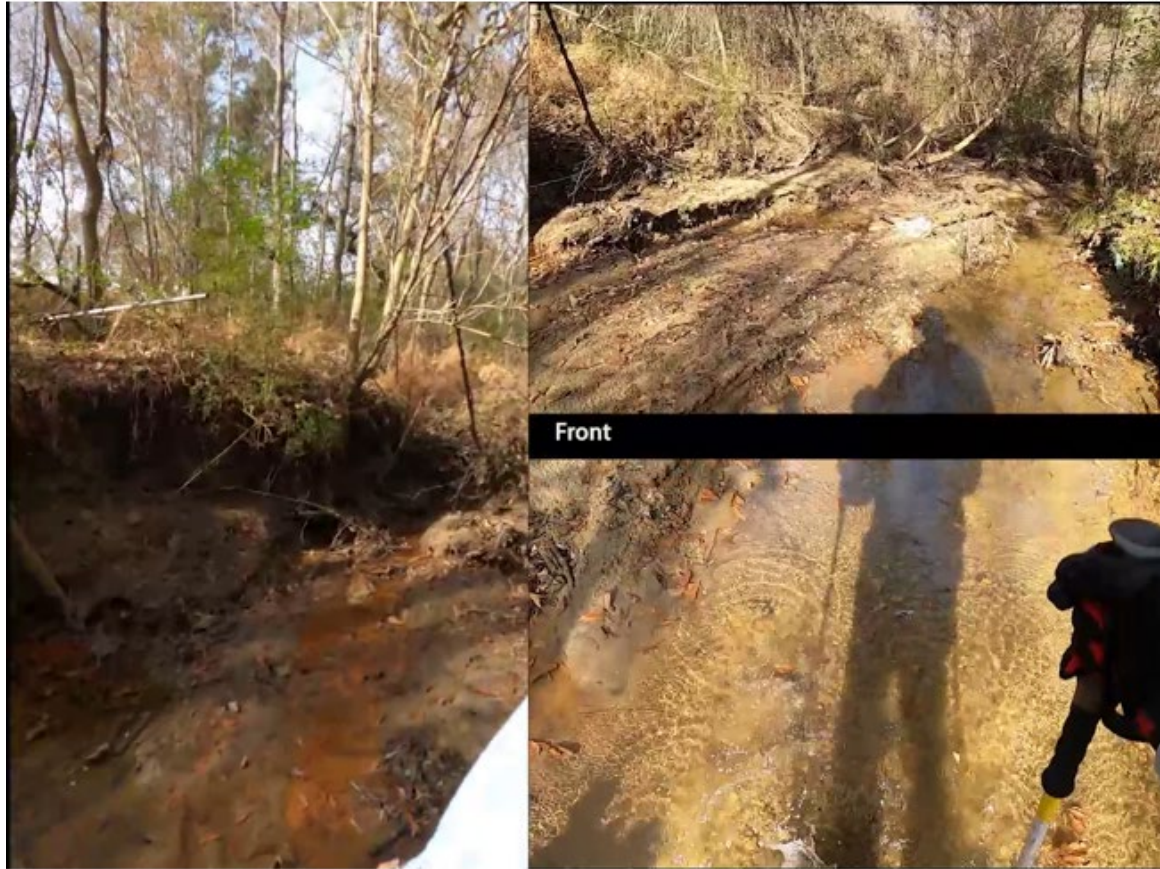
*Figure 50: Image of seep/spring discrete point feature located along the The Hub segment of a related tributary for the Parkerson Mill Creek survey near Auburn University, Auburn, AL.*

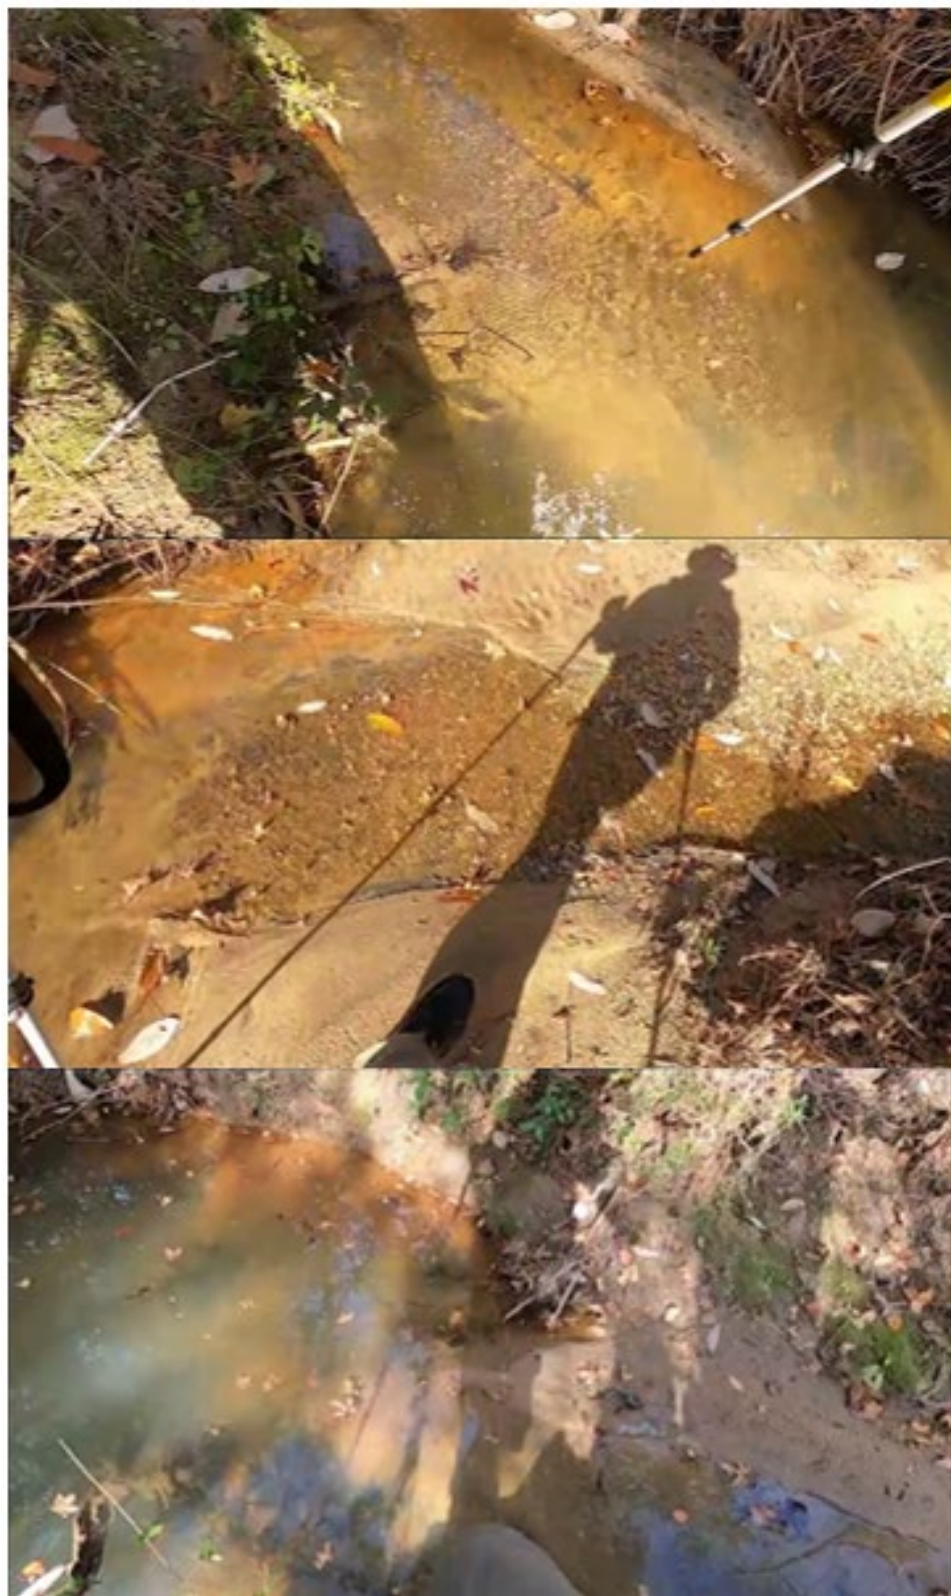
*Figure 51: Individual images a cluster of three seep/spring discrete point features located along the CDV Laundry segment of a related tributary for the Parkerson Mill Creek survey near Auburn University, Auburn, AL. Top photo being the most downstream location and the bottom being the most upstream location.*
