# HDSS Survey of Parkerson Mill Creek *Project Report*

**Michael Freeman**  
**Dept. of Risk Management and Safety**  
**971 Camp Auburn Rd.**  
**Auburn University, AL 36849**

November 13, 2024

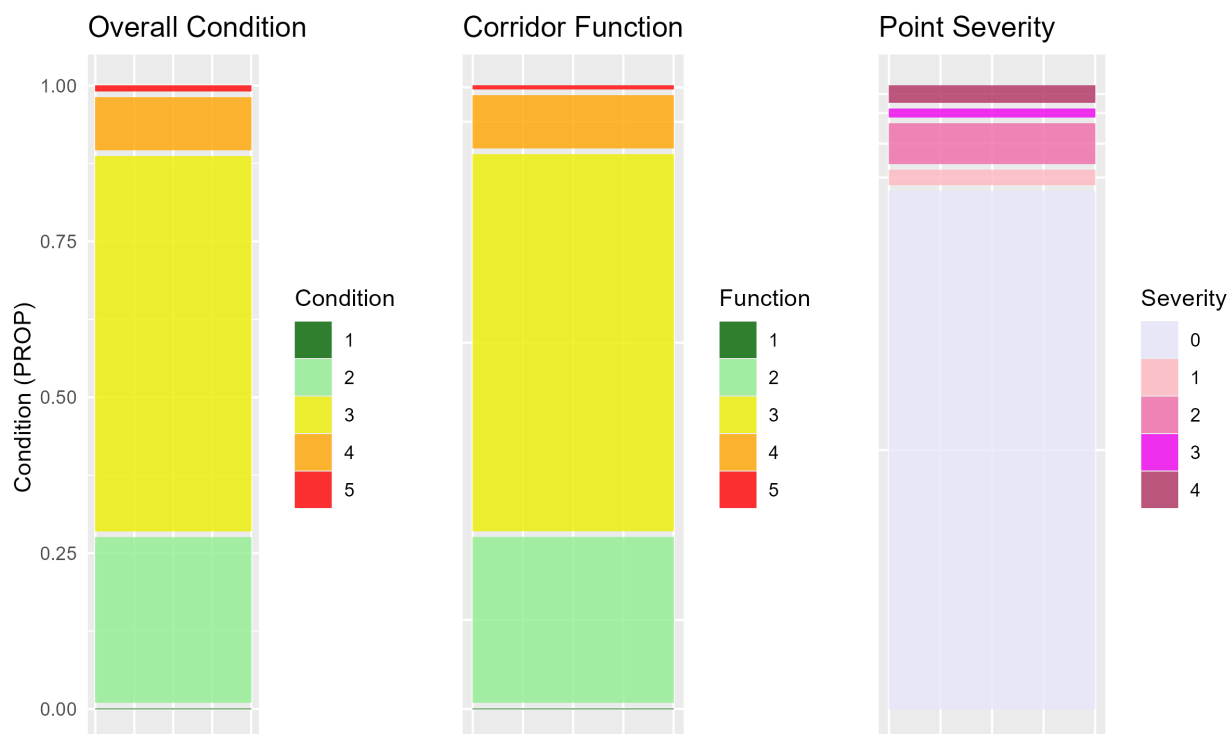
Figure 29: Overall Condition, Corridor Function and Point Severity along Parkerson Mill and related tributaries project.

Results at the overall project level for the mainstem of the Parkerson Mill Creek and tributary streams combined, show the corridor was generally in average condition (Figure 29). The Overall Condition scores were 62.6% Average, 27.5% Sub-optimal, and less than 10% scoring as Poor or Very Poor (Table 10). Spatially, the upstream portions of the watershed were generally in worse condition compared to downstream segments (Figure 30). The Overall Condition score reflects the impacts of Functional and Discrete Point Feature severity score combined. The Overall Functional score, which considers the continuous riparian, streambank, and streambed function, also showed the system to be in an average state. Of the surveyed area, 26.1% scored Functional or better while less than 68% scored Slightly Impaired and Impaired. Less than 1% of the sites scored Non-functional (Table 10). The other component of the Overall Condition score was the discrete point feature (Point) severity score. As expected, most locations had no discrete point features, with just over 244 m showing some impact from points on the stream corridor with 12 m having points in the two most severe categories. The combination of the more severe points in areas with degraded corridor function resulted in less than 1% of all areas being classified as Very Poor in the Overall Condition category.

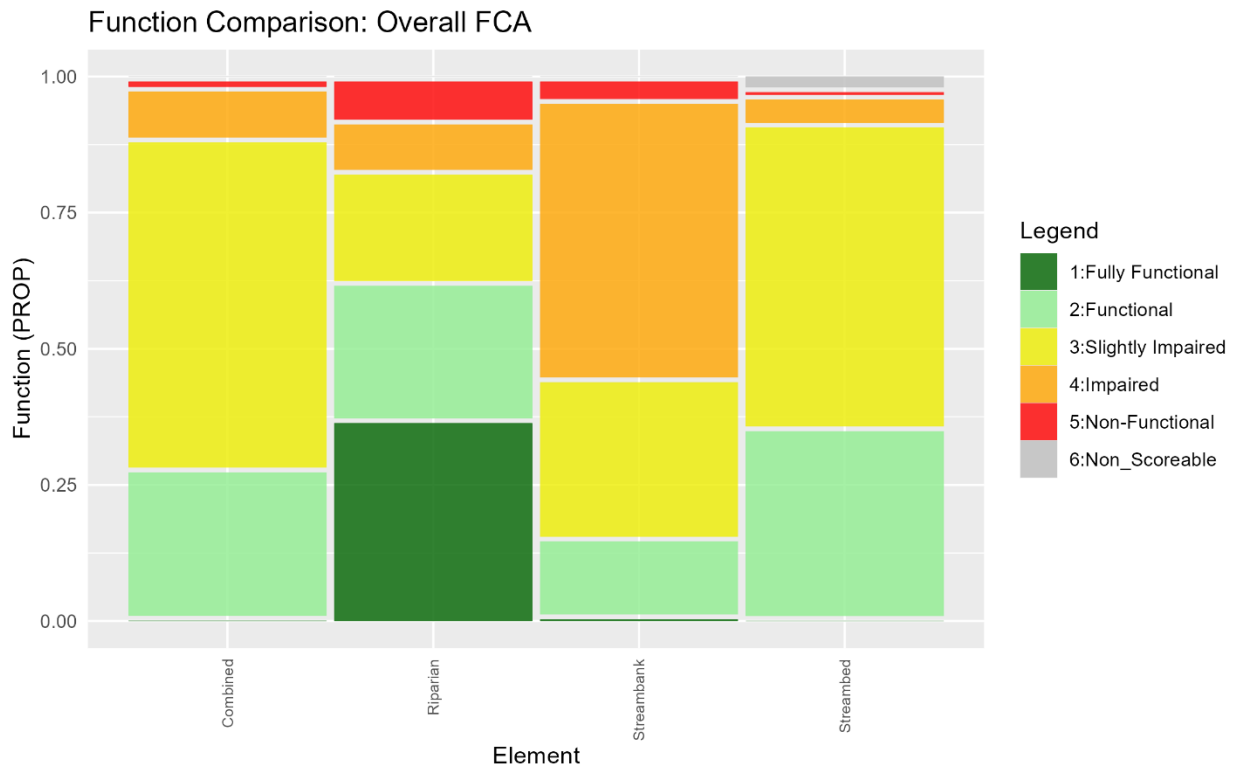
When considering Functional scores for the stream corridor at the project level, the riparian element was in the best condition, while also having the greatest percent Non-functional (Figure 31). The riparian had over 5.5 km scored as Fully Functional while streambanks had approximately 50 m and no sections of the streambed scored as Fully Functional (Table 11). Left and right streambanks consistently scored as Impaired, 56.6% and 48.8%, respectively, while the streambed consistently scored as Slightly Impaired (57.5%). Although the number of meters scored as Impaired and Non-functional in the riparian (2,302 m), streambank (8,080 m), and streambed (349 m) elements, we observed a limited number of meters (680 m) in which all five elements were scored as Impaired or Non-Functional (Figure 32). Additionally, a portion of the streambed immediately upstream of an impoundment, where the water surface elevation often fluctuates due to rainfall events was non-scoreable due to not having a defined channel.

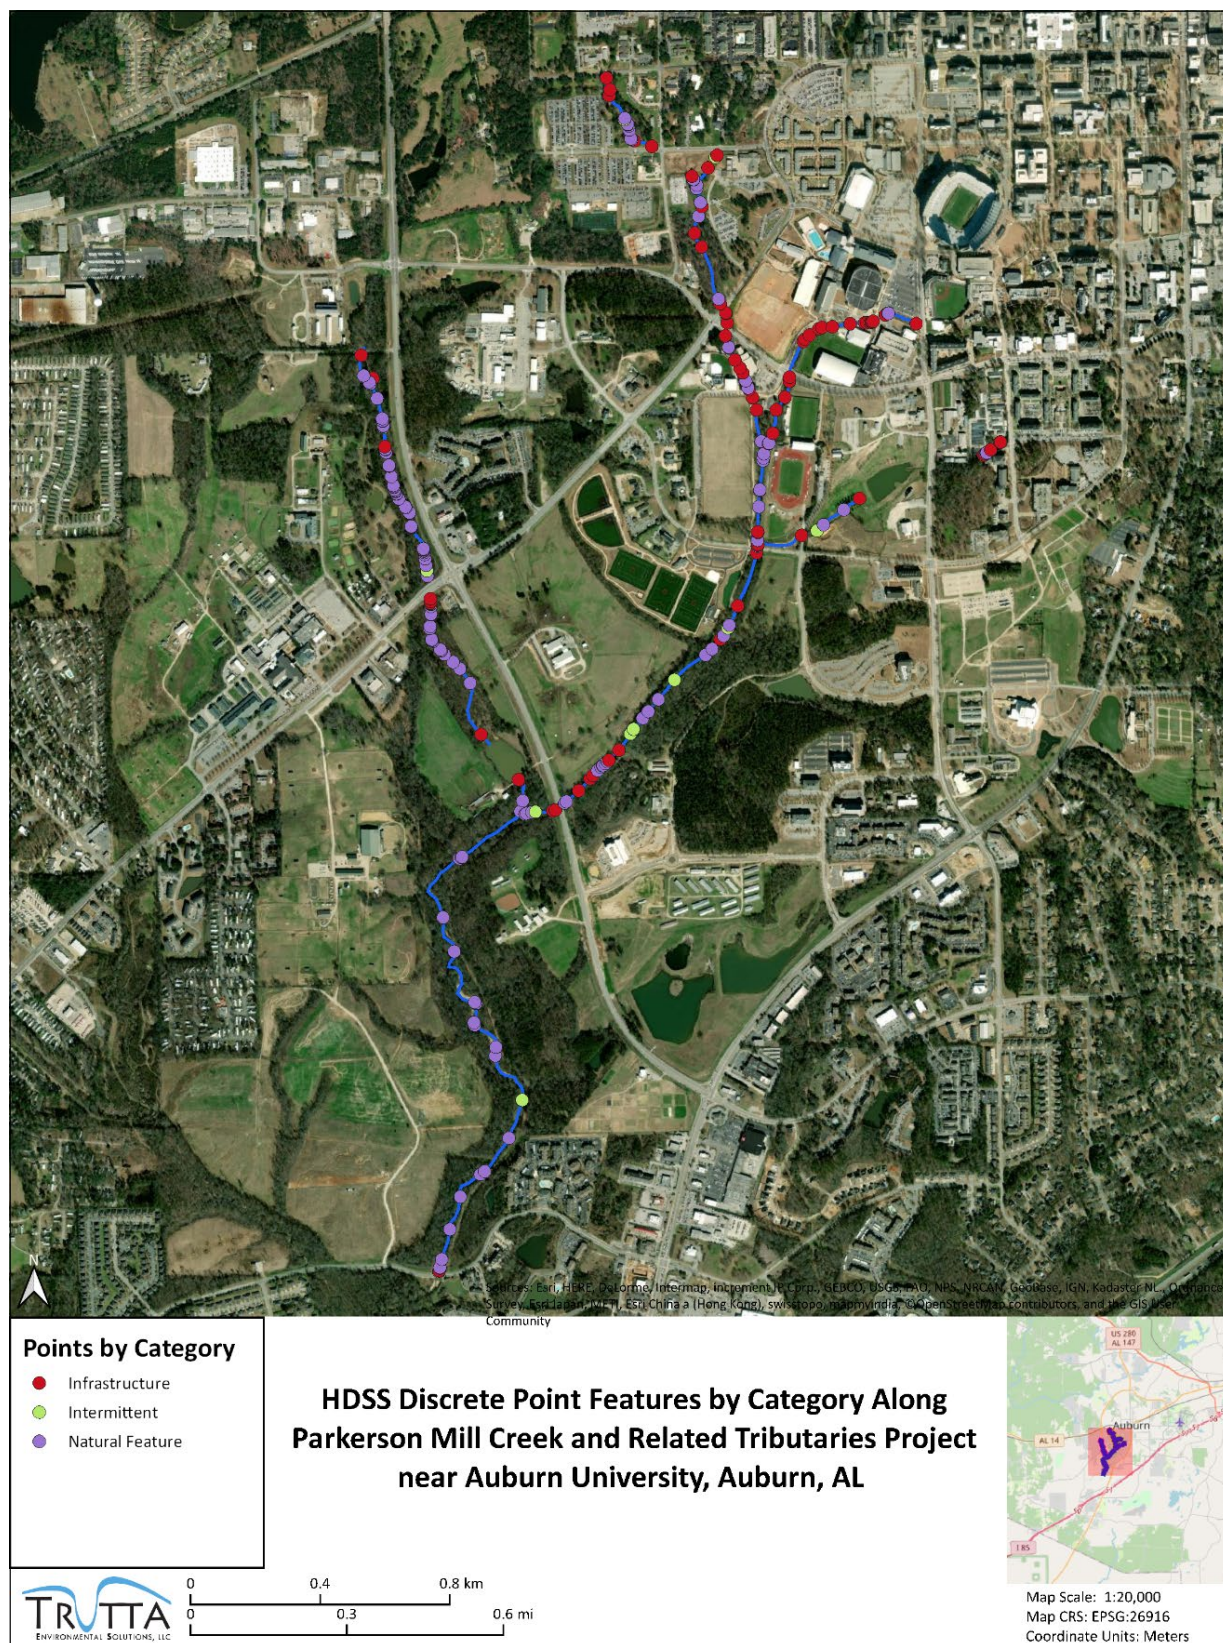
Figure 33: Discrete Point Features classified by Category along Parkerson Mill Creek and related tributaries near Auburn University, Auburn, AL.

At the project level, a total of 282 discrete points were documented within the Complexity category (Class - Natural Features, e.g., large woody debris) accounting for the majority of points (Table 12). Of these 282 points, only 20 had a severity rating of Moderate or greater (Table 13). These 20 points would likely have an impact on the overall condition of the stream corridor. The majority of these points fell into the Pipe and Road categories which include points such as exposed pipes (n=4) and outfalls (n=5) and culverts (n=5), respectively. Spatially, most infrastructure discrete point features were in the upper portions of the watershed while natural features and Intermittent features were generally evenly distributed throughout the basin (Figure 33).

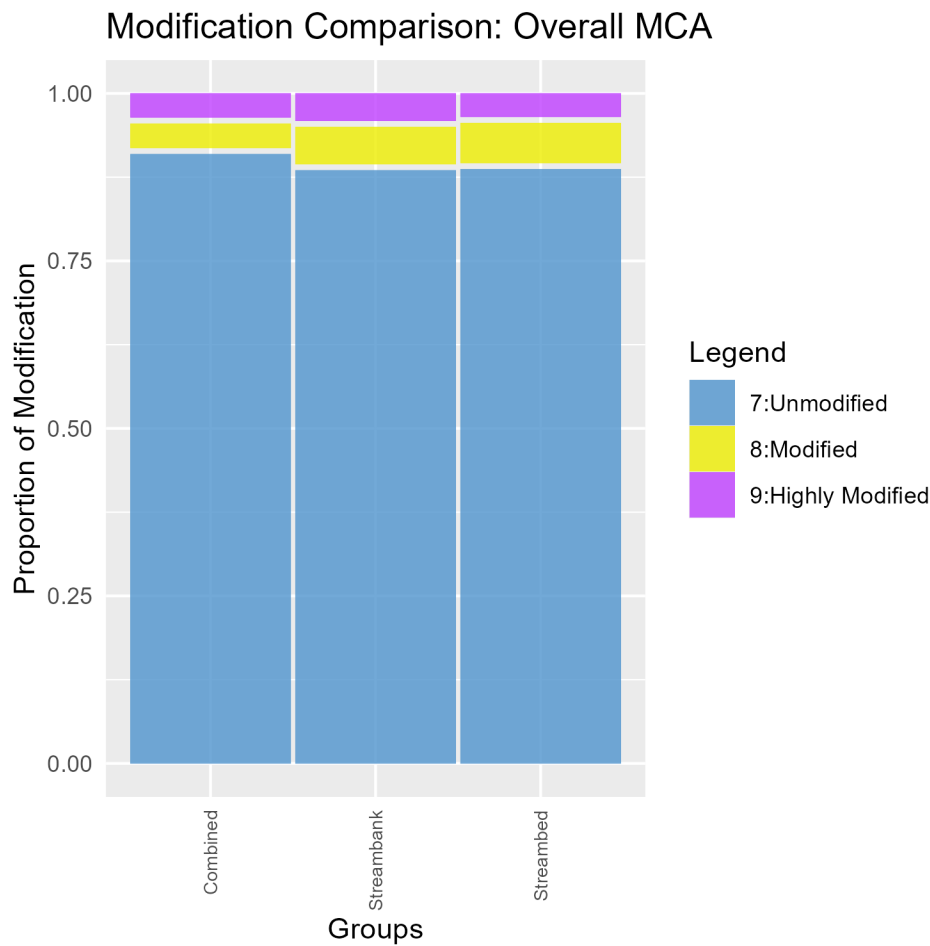
When viewing the extent of modification to the stream corridor at the project level, the majority of the surveyed area was Unmodified with only a small percentage being classified as Highly Modified and Modified, 3.6% and 3.7% respectively (Figure 34). When assessing each of the individual elements of streambed and left and right streambank, the left streambank had nearly twice the distance documented as Modified compared to the right streambank (Table 14). Spatially, the most upstream portions of the watershed generally had more Modified and Highly Modified modifications when compared to most downstream segments (Figure 35). This likely reflects the impacts of hydrologic modification by the stormwater flows throughout the system.

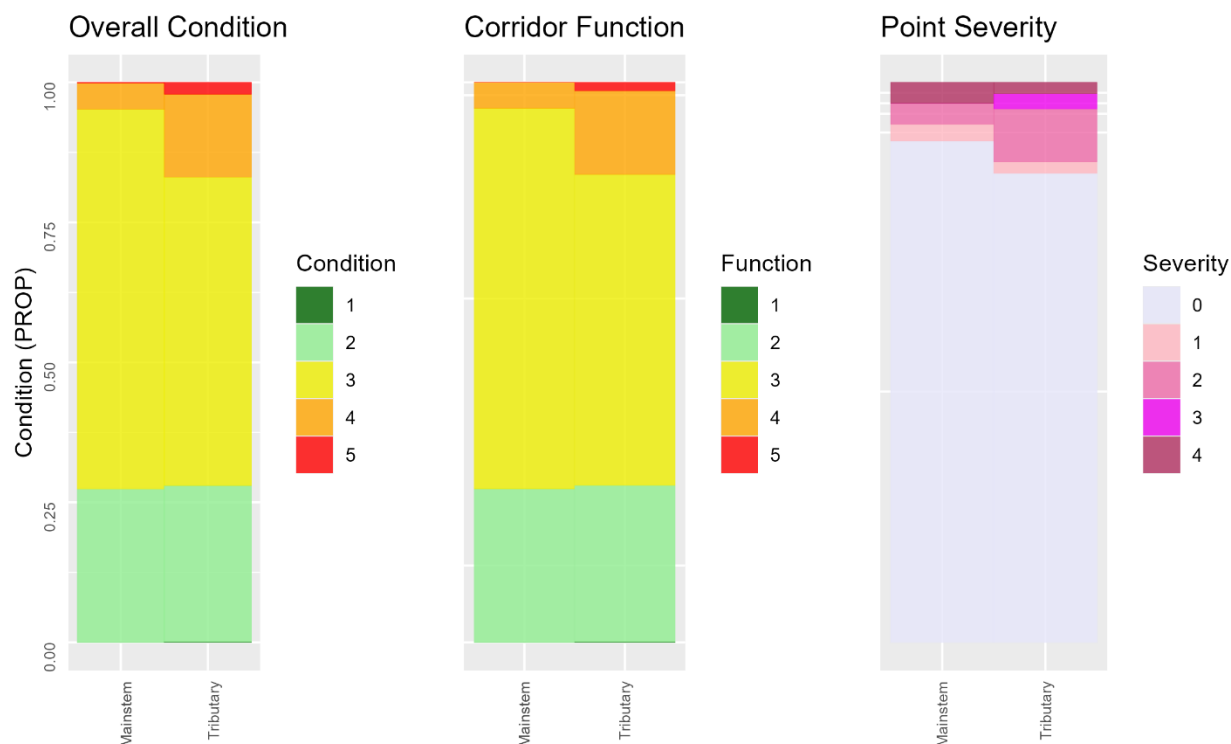
Figure 36: Overall Condition, Corridor Function and Point Severity comparing the mainstem Parkerson Mill Creek versus the combined tributaries surveyed.

Clear differences were observed between the Overall Condition of the mainstem Parkerson Mill Creek and its tributary streams (Figure 36). The Parkerson Mill Creek scored better than the tributary streams along the Poor and Very Poor metrics (Table 15). The Parkerson Mill Creek had 5% of its length scored as Poor and Very Poor, while nearly 17% of the tributary streams fell into these categories. Similarly, 95% was scored as Sub-optimal and Average for Parkerson Mill Creek while only 83% of the tributary streams were rated in these categories. These trends were consistent with both the Corridor Function and Points Severity on the corridors, with the tributary streams scoring poorer function and greater impact from points for the given length. When comparing the Combined Function Score between the mainstem Parkerson Mill creek and all tributaries combined, 27.4% of the corridor Function scores along Parkerson Mill creek were Functional or better, while 27.9% of the tributary stream were classified into the Functional or better groups (Figure 36; Table 15; Table 16).

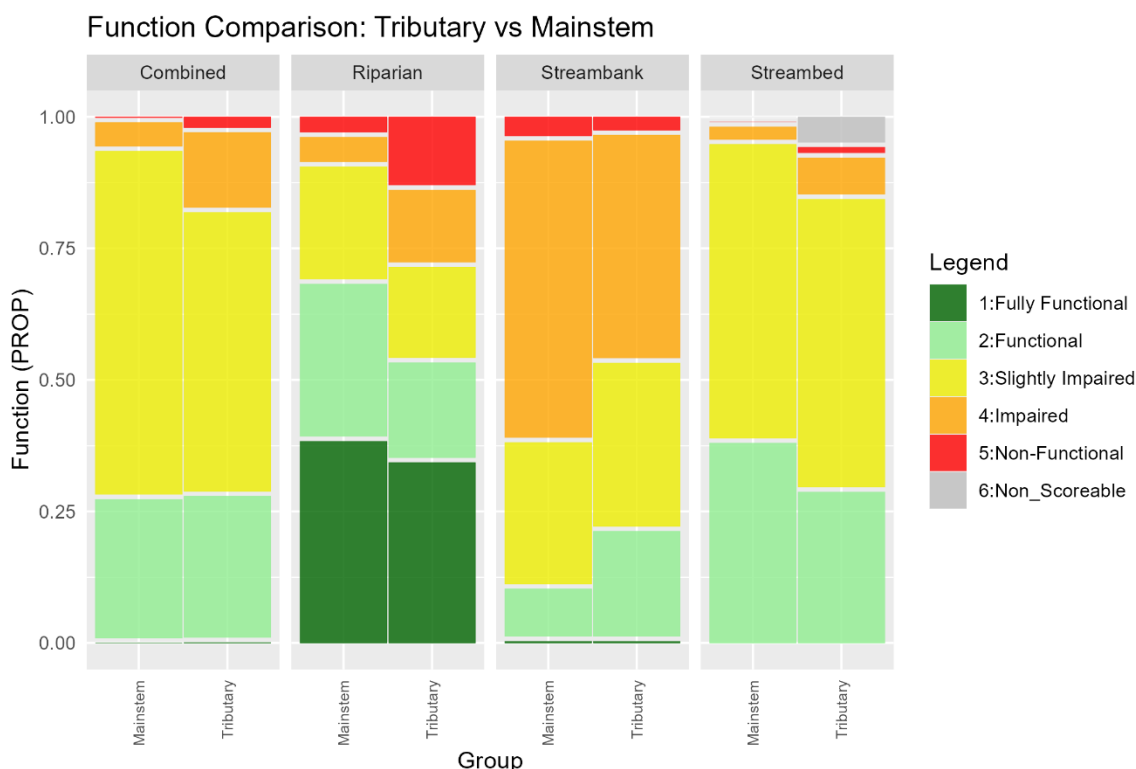
Differences among the Functional elements of streambed, streambanks, and riparian were also recorded between mainstem and tributaries. These differences were most obvious among the elements of Riparian and Streambed (Figure 37; Table 17; Table 18). For the tributaries, a greater proportion of the streambed (nearly 8%) and riparian areas ( $\geq 24\%$ ) were classified as Impaired or Non-functional when compared to the streambed (2.5%) and riparian areas ( $< 10\%$ ) for Parkerson Mill Creek. The Fully Functional classification occurred most within the functional element of Riparian for both mainstem and tributary streams. However, the riparian scores for the tributary streams were generally worse than those observed on the mainstem.

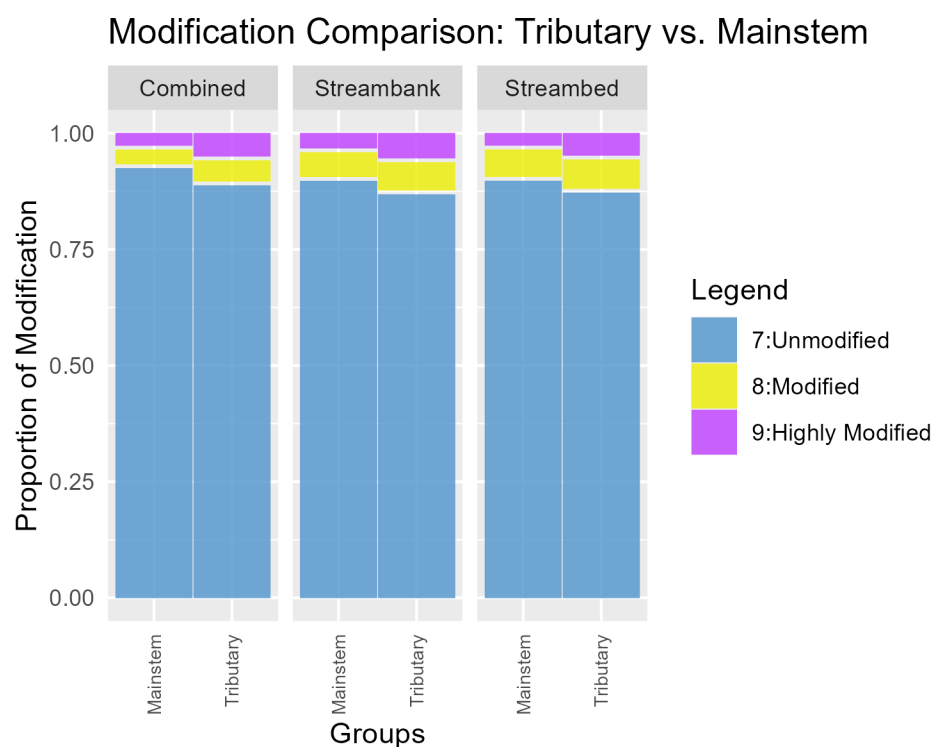
The extent of modification to the system was slightly greater along the tributary streams compared to the mainstem. For Streambed modification scores, 91.5% of the Parkerson Mill Creek mainstem was scored as unmodified while 88.7% of the tributaries scored as unmodified (Figure 38; Table

21). Additionally, unmodified streambanks along the mainstem ranged from 88.6% to 94.3% while streambanks along tributaries ranged from 87.8 % to 89.1%. The extent of modification was similar between the streambank and streambed elements in both the river and tributary streams.

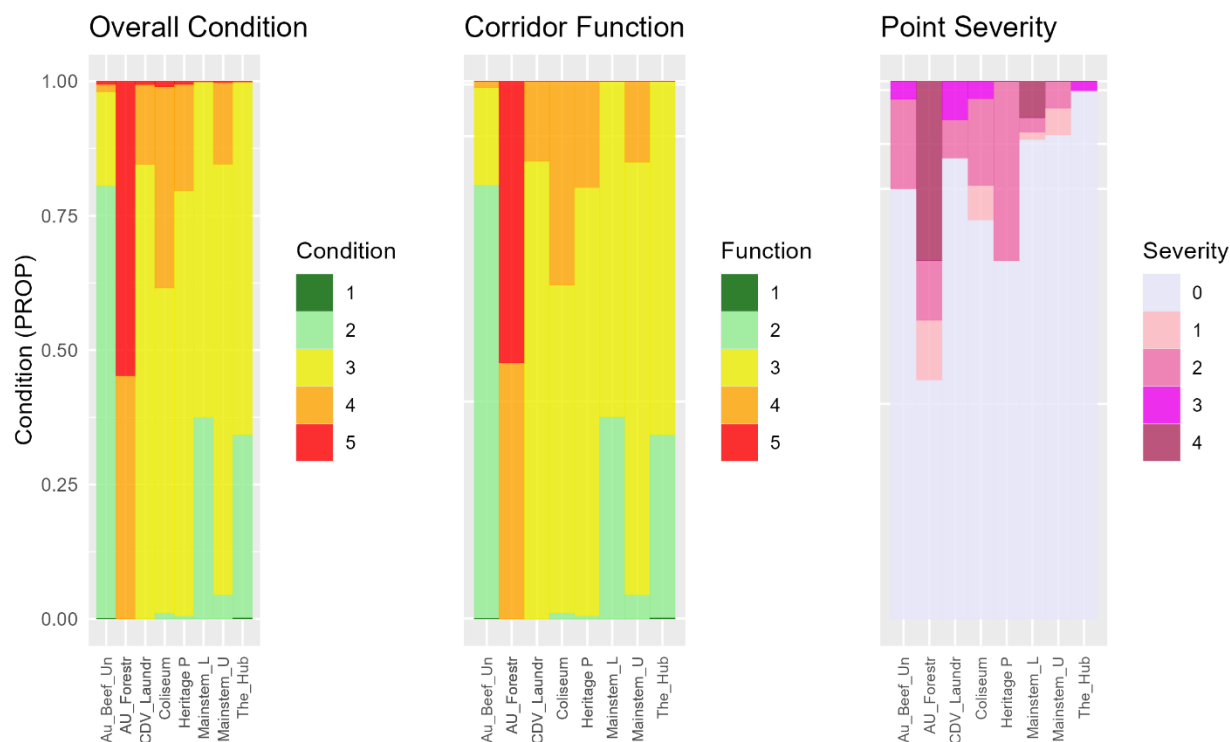
Figure 39: Overall condition, corridor function and point severity among segments surveyed along Parkerson Mill and related tributaries.

The Overall Condition scores for the Parkerson Mill Creek segments were generally in average condition. All segments, except for the AU Beef unit, scored Average or worse for  $\geq 62\%$  of the total segment (Figure 39). The AU Beef Unit segment had the highest percentage Optimal and Sub-Optimal scores of 80% followed by Lower Mainstem and The Hub segments, respectively (Figure 39; Table 22; Table 23; Table 24; Table 25; Table 26; Table 27; Table 28; Table 29). The AU Forestry segment demonstrated the worst Overall Condition followed by the Coliseum segment. Combined Corridor Function scores were similar to Overall Condition scores among segments. Additionally, Overall Point Severity scores continued to demonstrate a similar trend as the Overall Function segment scores, highlighting areas in need of management action. The two segments, AU Forestry and Coliseum segments were in the worst Overall Condition and Corridor Function. These ratings were due to restoration efforts currently underway in the AU Forestry segment and the urbanization that has occurred along the Coliseum segment.

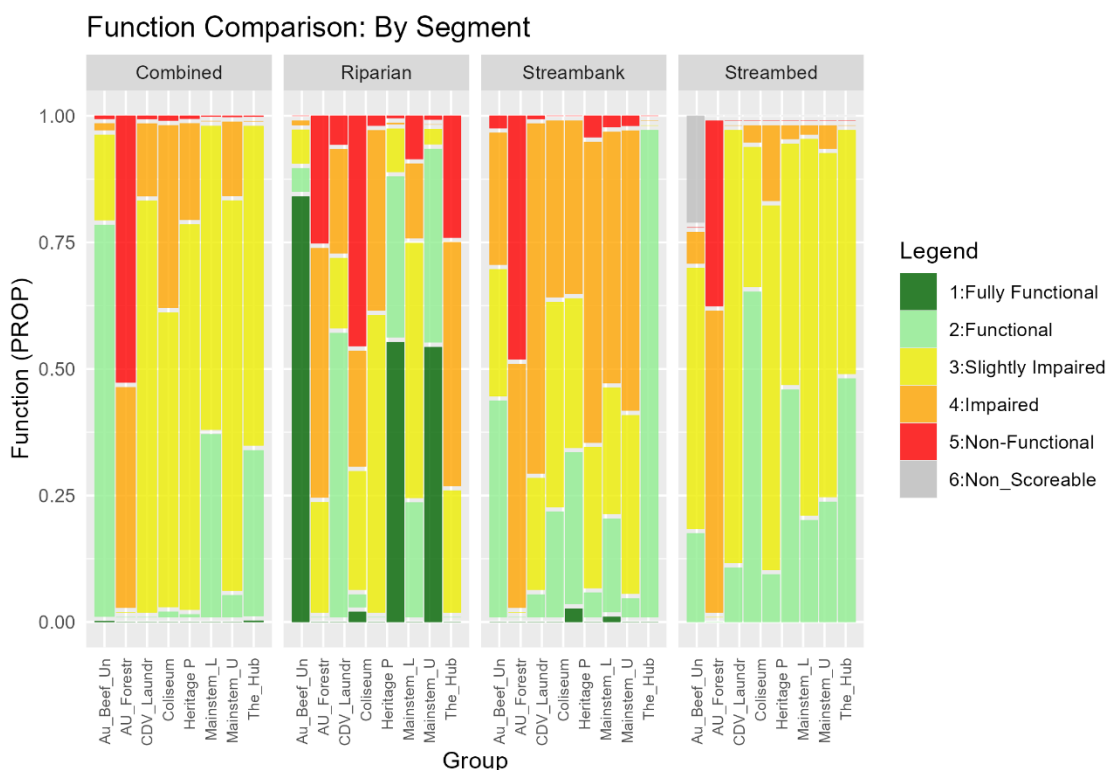
Figure 40: Functional comparison of streambed, streambank, and riparian among segments surveyed along Parkerson Mill and related tributaries. Note- left and right streambank and riparian values were combined for this analysis to provide a single value for streambank and a single value for riparian.

The functional rating among the elements of left and right riparian and streambanks and streambed varied considerably among the segments. When viewing the riparian element, function was relatively good along the Lower Mainstem, the AU Beef Unit, and The Hub segments (Figure 40) with these segments having the greatest proportion of Fully Functional classifications. AU Forestry, Coliseum, and Upper Mainstem, Heritage Park, CVD Laundry, and Upper Mainstem segments had the greatest proportion of Non-Functional and Impaired classifications, respectively (Table 30; Table 31; Table 32; Table 33; Table 34; Table 35; Table 36; Table 37). Among streambanks, only two segments, Heritage Park and Upper Mainstem, had any portion of their streambanks classified as Fully Functional, which only accounted for 4% and 2.1%, respectively. Whereas streambanks had

greater than 50% of the segment classified as Slightly Impaired to Non-Functional. As for streambed, AU Forestry was the only segment to be entirely classified as Impaired or Non Functional and no proportion of any segment was classified as Fully Functional. The Functional element of streambed had the greatest proportion of non-scorable in the AU Beef Unit, which was due to the upstream portion of the impounded areas where a defined streambed did not conform to the traditional classification and would be considered a multithreaded channel.

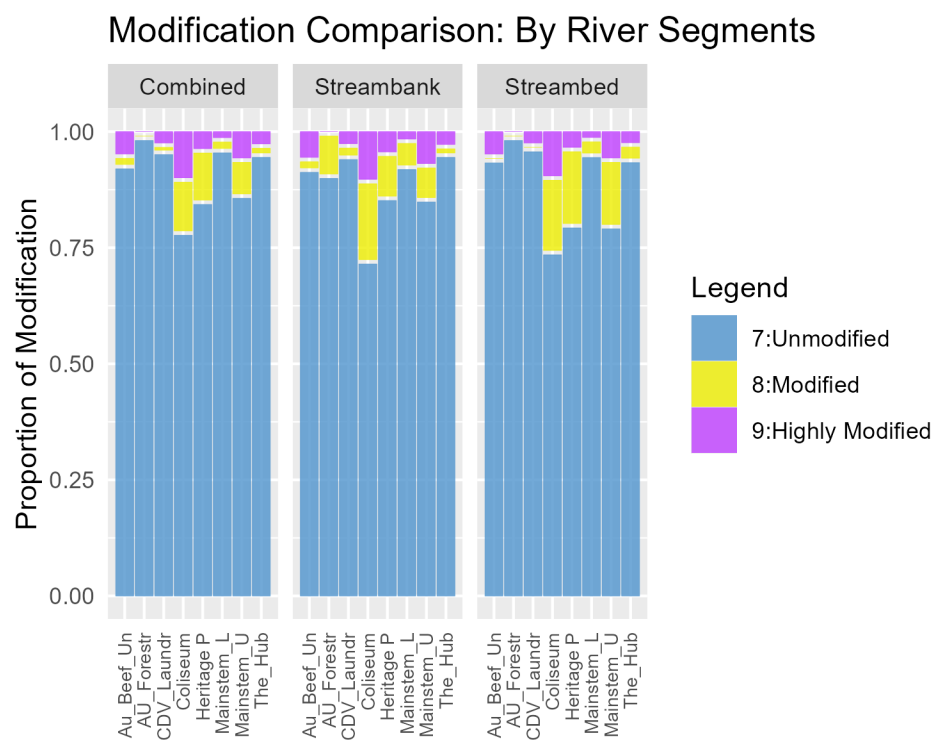
The extent of modification varied among the segments. Combined modification indicates that greater than 75% of all segments were unmodified (Figure 41). All segments had a Modification of Modified or Highly Modified recorded along their streambed and streambanks, with the AU Forestry segment being the only exception; however, this segment was currently in the early stages of restoration construction. Among segments, the Coliseum segment had the greatest percentage of modification followed by Heritage Park and Upper Mainstem segments. For streambed modification, the Coliseum segment had the greatest percentage (9.7%) of the segment classified as Highly Modified followed by Upper Mainstem (5.8%), AU Beef Unit (4.9%), and Heritage Park

(3.4%) segments (Table 40; Table 41; Table 42; Table 43; Table 44; Table 45; Table 46; Table 47). As for the Modified classification of streambed, the Heritage Park segment had the greatest percentage (15.8%) classified as such, followed by Coliseum (15.4%), and Upper Mainstem (13.6%) segments.

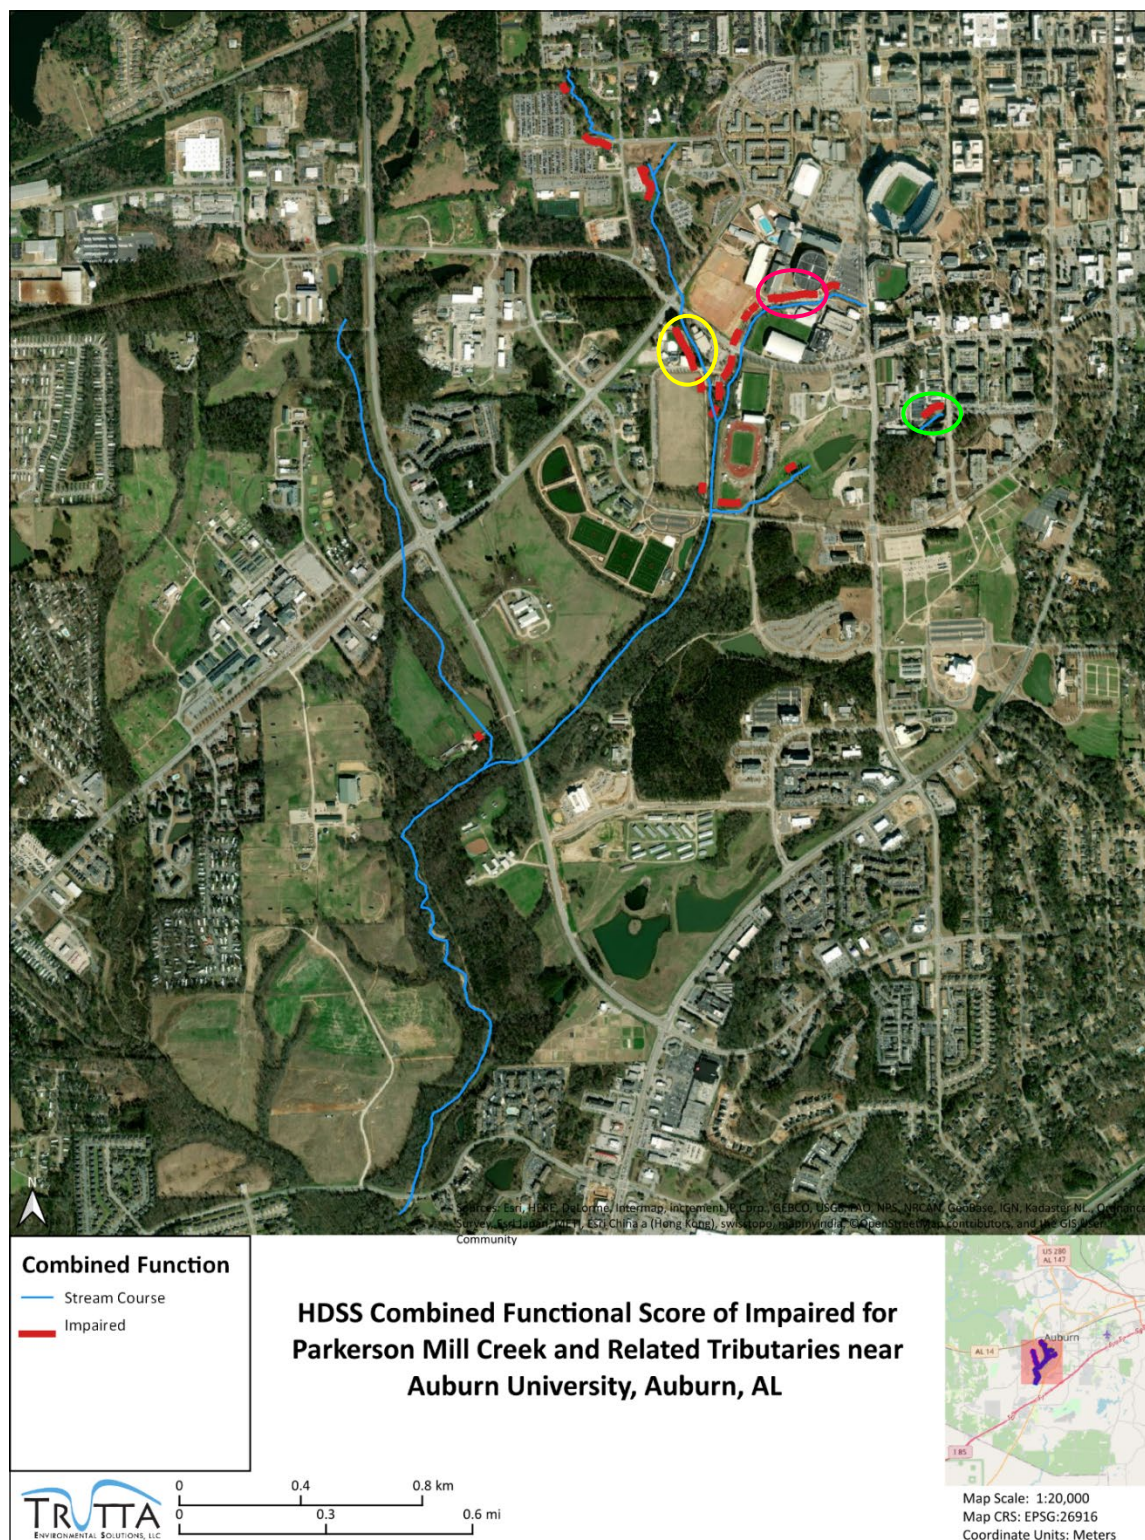
Figure 42: HDSS Combined Functional Score of only Impaired used to identify and prioritize areas in greatest need management action. Specific areas of interest include Jane B. Moore Field (yellow), Biggio Dr. (purple), and AU Forestry (green).

Utilizing the SCA Condition Assessment factor of Combined Functional score, the stream corridor between the McWhorter Center and Jane B. Moore Field, in the Upper Mainstem segment, had one of the longest and most consistent score of impaired within the basin (Figure 42, Figure 43), with only one other location of similar score and magnitude present (along the northeast section of Biggio Dr.). By using the Combined Functional score, we can easily identify the degree of perturbation (score), as well as the scope and magnitude throughout the basin to develop a prioritization ranking system for the entire basin. Additionally, the Combined Functional classification of Worst for the stream corridor along the AU Forestry segment highlights the current conditions of this segment. However, this is expected since this segment is at an early stage of restoration.

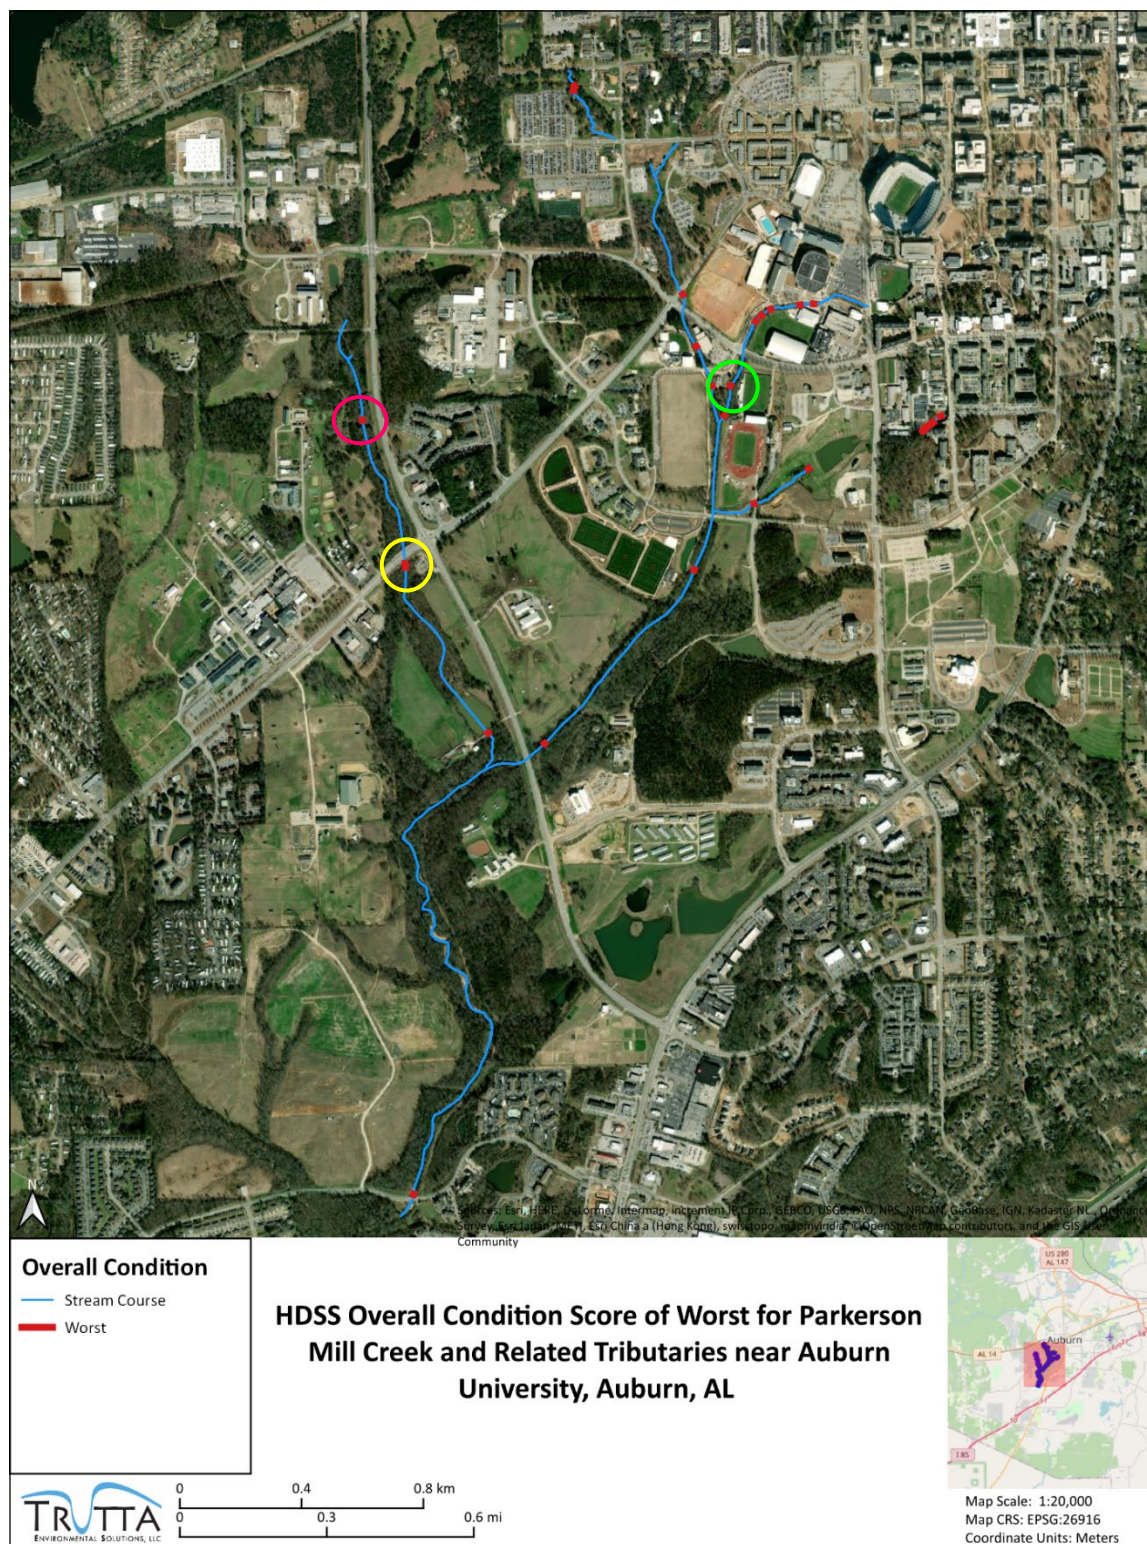
Using the Overall Functional score, we can easily identify two areas in need of management action. The stream reach near Pratt-Carden Dr. (Figure 45), along the AU Beef Unit segment (Figure 46), and the reach near the Auburn Soccer Complex, along the Coliseum segment (Figure 47), were two of the worst locations based on the Overall Condition score within the basin. By using the Overall Condition score we can easily identify the degree of perturbation (score), as well as the scope and magnitude throughout the basin to develop a prioritization ranking system for the entire basin. The Overall Condition score of a reach along The Hub segment, was classified as one of the worst reaches; however, this classification was influenced by a natural feature (e.g., log/debris jam) and not infrastructure (Figure 48). Additionally, the AU Forestry segment was again highlighted as one of the worst segments; however, we understand that this reach is currently undergoing a major stream restoration effort.

Figure 45: HDSS Overall Condition Score of only the worst reaches used to identify and prioritize areas in greatest need of management action. Specific areas of interest include Pratt-Carden Dr. crossing (yellow), Auburn Soccer Complex. (green), and The Hub (purple).

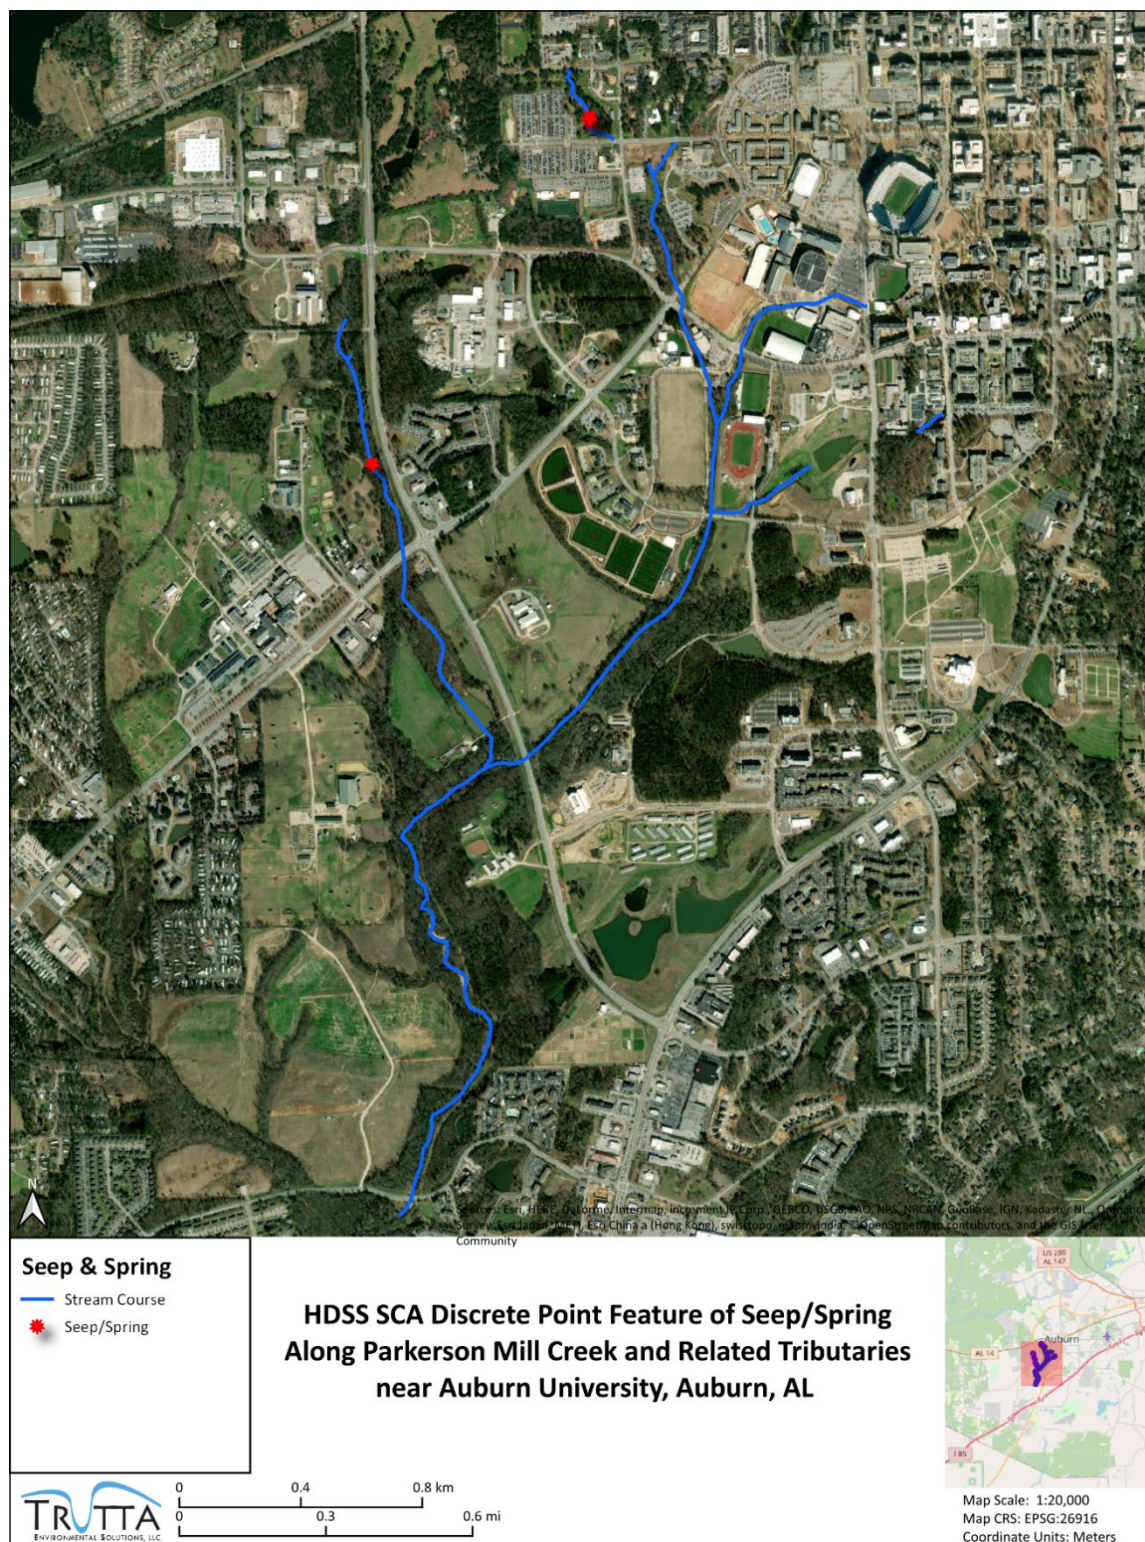
While the combined data from the SCA-Condition Assessment provides a robust framework for watershed management, the individual elements, such as discrete point features, offer a straightforward and effective means for prioritizing management actions or determining necessary interventions. Documenting specific features like seeps and springs is particularly useful for identifying areas that may require further investigation or immediate action. For instance, during the survey, four discrete seep/spring point features were recorded (Figure 49), helping to highlight potential locations of concern that may impact stream health.

At one of these locations, a single seep/spring was documented along the segment referred to as "The Hub" (Figure 50), while a cluster of three seeps/springs were identified along the CDV Laundry segment (Figure 51). In all cases, discolored water was observed slowly percolating from the streambed or streambank, indicating potential contamination or other subsurface issues. These areas, especially where clusters were recorded, could benefit from additional investigation to determine if they represent significant point sources of contamination or other environmental concerns.

Figure 49: Seep/Spring discrete point feature locations identified along the Parkerson Mill Creek and related tributaries near Auburn University, Auburn, AL.
