Auburn University Municipal Separate Storm Sewer System (MS4)

Annual Report 2019/2020

Auburn University, Lee County (081) Alabama

MUNICIPAL SEPARATE STORM SEWER SYSTEM (MS4) ANNUAL REPORT REPORTING PERIOD APRIL 1, 2019 – MARCH 31, 2020

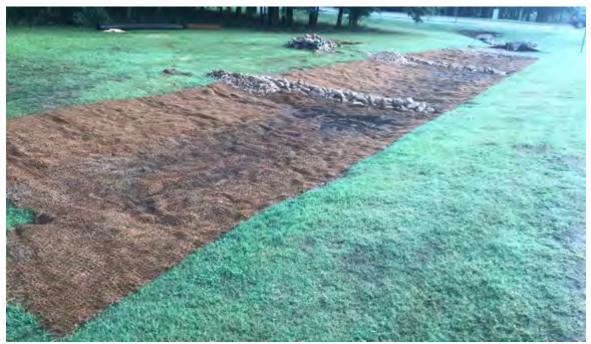
Figure 1: Finished construction of the downstream end of the project site.

This project will help with addressing the components in the Parkerson Mill Creek Watershed Management Plan by installing low impact development best management practices (LID

BMPs) to mitigate urban runoff quality and quantity on the Auburn University campus. Research shows that LID BMPs, such as roadside vegetated filter strips and bioswales, play an important role in urban watersheds in decreasing urban stormwater runoff quantity and improving runoff quality. Furthermore, LID BMPs such as these are more cost effective as compared to conventional, hard-engineered stormwater infrastructure. In spring and summer 2019, the first step pools and rock filter dams were constructed (Figure 1) at the site to slow down stormwater runoff and to facilitate stormwater infiltration. Each pool was vegetated with with muhly grass (*Muhlenbergia capillaris*), cone flower (*Echinacea purpurea*) and swamp milkweed (*Asclepias incarnata*).

The 2nd section of the bioswale was constructed in March 2020. Existing grass was terminated in fall 2019 to reduce weed pressure after construction. A tractor mounted and PTO driven cultivator was used to till the soil surface. A 2" layer of compost was added to the soil to improve physical and chemical soil properties. The compost was incorporated with the cultivator. Additional 16 rock filter dams were constructed at 1 foot elevation increments according to the Alabama Handbook for Erosion Control, Sediment Control and Stormwater Management on Construction Sites and Urban Areas. The BMP design of the rock filter dam is attached in the appendix. The west end of the 2nd section was vegetated with muhly grass (*Muhlenbergia capillaris*), cone flower (*Echinacea purpurea*) and swamp milkweed (*Asclepias incarnata*) in April 2020. The east end of the 2nd section is planned to be vegetated at the end of April / beginning of May 2020 depending on the COVID-19 restrictions and availability of plants from nurseries.

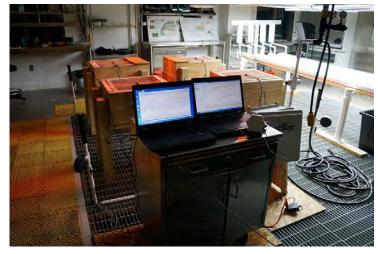
Thermal pollution to receiving waters is an urban storm water problem throughout the world that negatively affects fish and wildlife habitat. Research conducted in the Green Infrastructure Laboratory Green Lab at the Mike Hubbard Center for Advanced Science, Innovation and Commerce

(CASIC) Building in the Auburn University Research Park, Auburn, AL explores this storm water problem. Here pavement cells receive simulated sun (infrared lamps), and rain (water sprinkler) events. Impervious pavement cells and turfgrass cells are used as controls. Data collected includes microcosm cell surface, internal cell temperature, and water temperature exiting cells. The importance of this research is that it has the potential to impact estuary conditions and receiving waters in Mobile Bay and beyond.

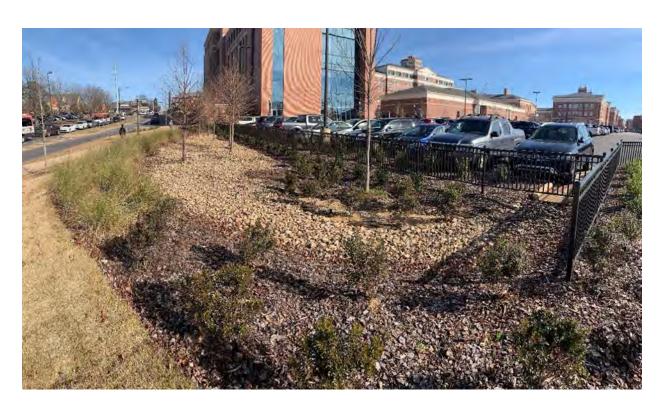
Bioretention Cell at Horton Hardgrave Hall (AU Project 14-044)

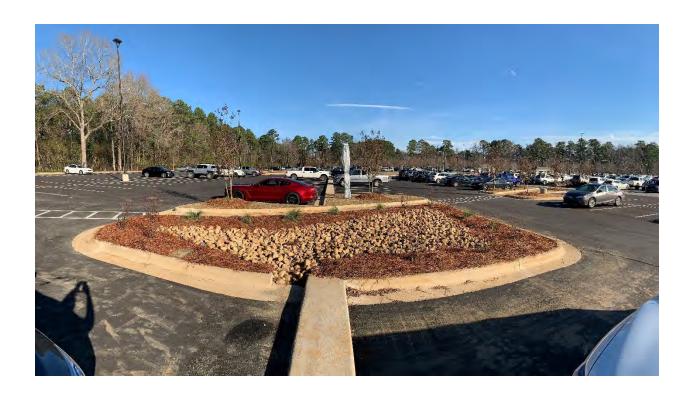
Bioretenion at the West Campus Parking Expansion (AU Project 19-037)

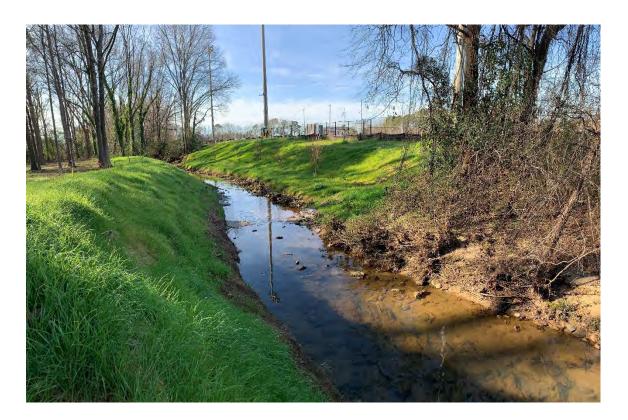
Stream Restoration at Parkerson Mill Creek Greenway Adjacent to Intramural Flelds (AU Project 19-169)

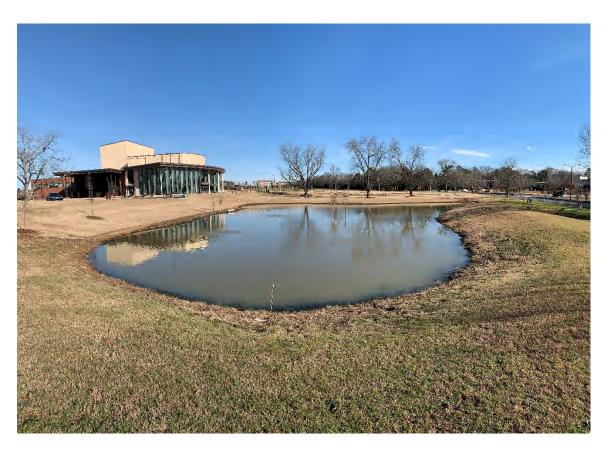
Regional Retention Pond at Gogue Performance Arts Center (AU Project 15-158)

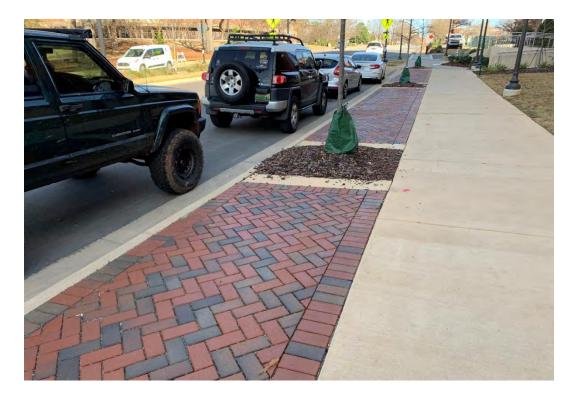
Pervious paving at the South College Street Parking Deck (AU Project 18-071)

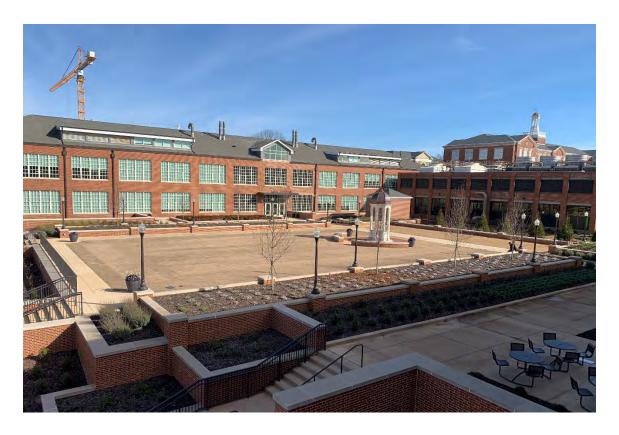
Green Roof at Brown Kopel Engineering Student Achievement Center (AU Project 15-157)
